**Addendum No. 01  
TO THE CONTRACT DOCUMENTS FOR:**

**Howard County Library Renovation**  
500 S Main Street  
Big Spring, TX 79720  
KAI Project No. 2024.129

**RE: Asbestos Inspection - Howard County Public Library**  
**500 S. Main Street**  
**Big Spring, Texas 79720**

## **ASBESTOS SURVEY COMPLETION REPORT FOR:**

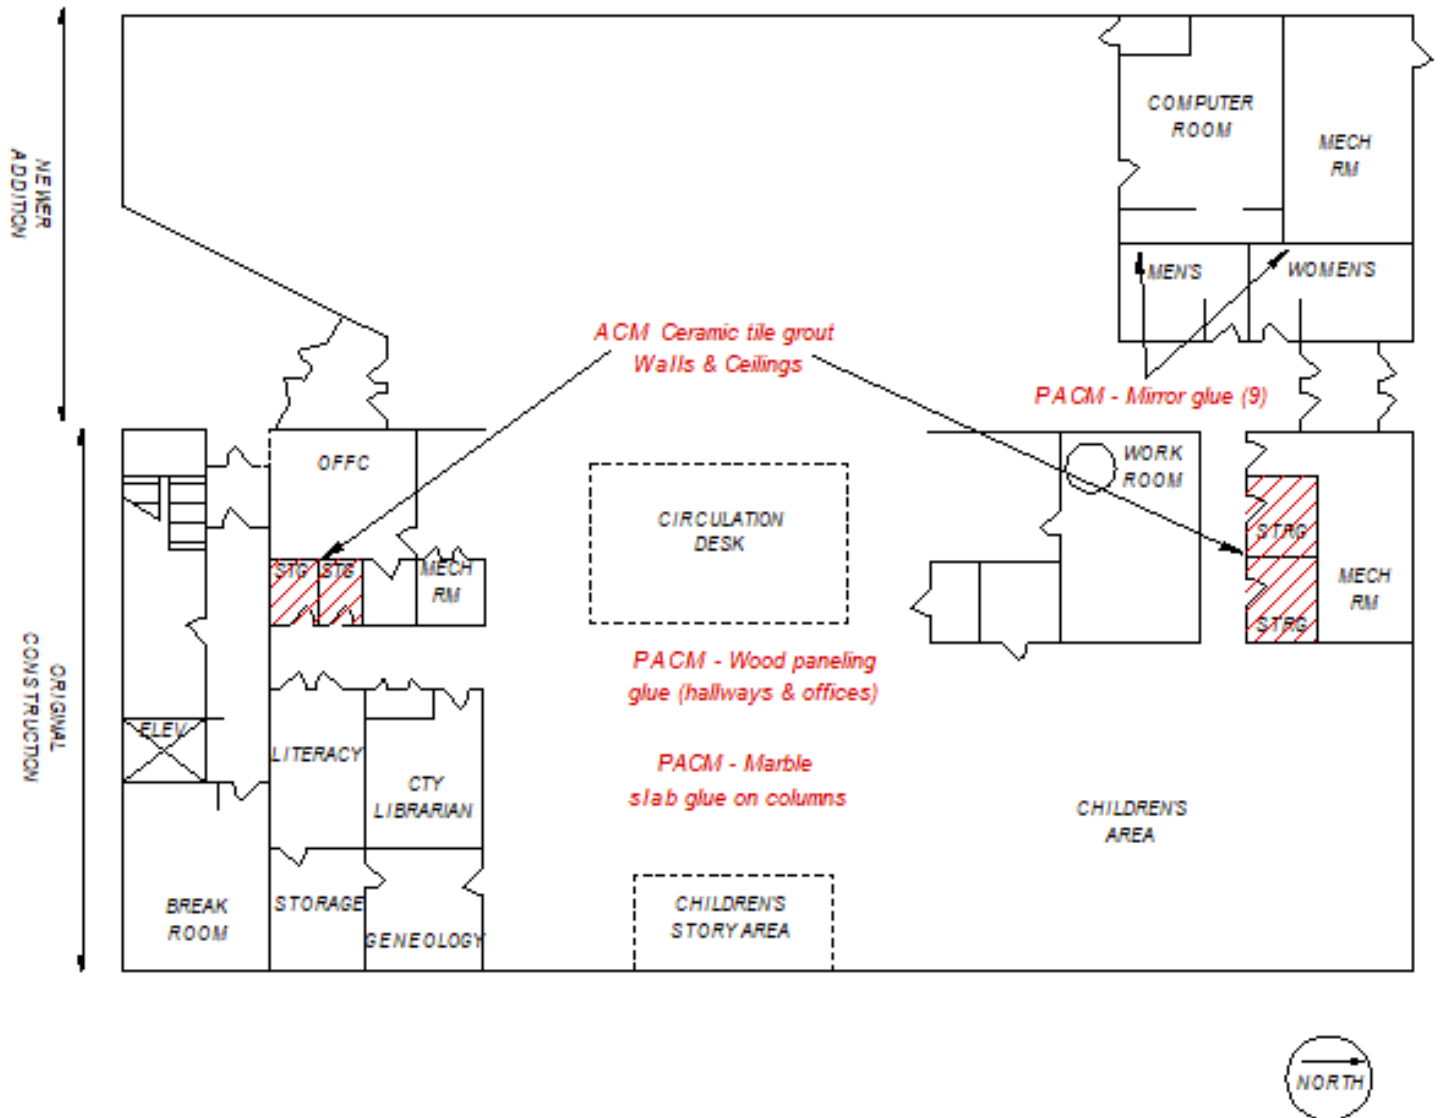
# ASBESTOS MATERIAL LOCATIONS

**ORIGINAL STRUCTURE – 1<sup>ST</sup> FLOOR**

- 800 ft<sup>2</sup> of wall & floor ceramic tile grout (2 south storage rooms/restrooms, 2 north storage rooms/restrooms)
- PACM – marble fascia glue (10 columns)
- PACM – wood paneling (hallways & offices)
- PACM – 9 units of mirror mastic (northwest restrooms)

Refer to the laboratory analysis report for more detailed material information. Please note that prior to renovation/demolition activities, the materials discovered to contain asbestos will need to be removed by Texas DSHS licensed abatement contractor under the supervision/monitoring of a Texas DSHS licensed consultant. Texas Consulting Services is available to provide cost estimates for this removal at the owners' request.
